# Holy Trinity Church, Torbryan, Devon

## Rood Screen Panels

March 2016

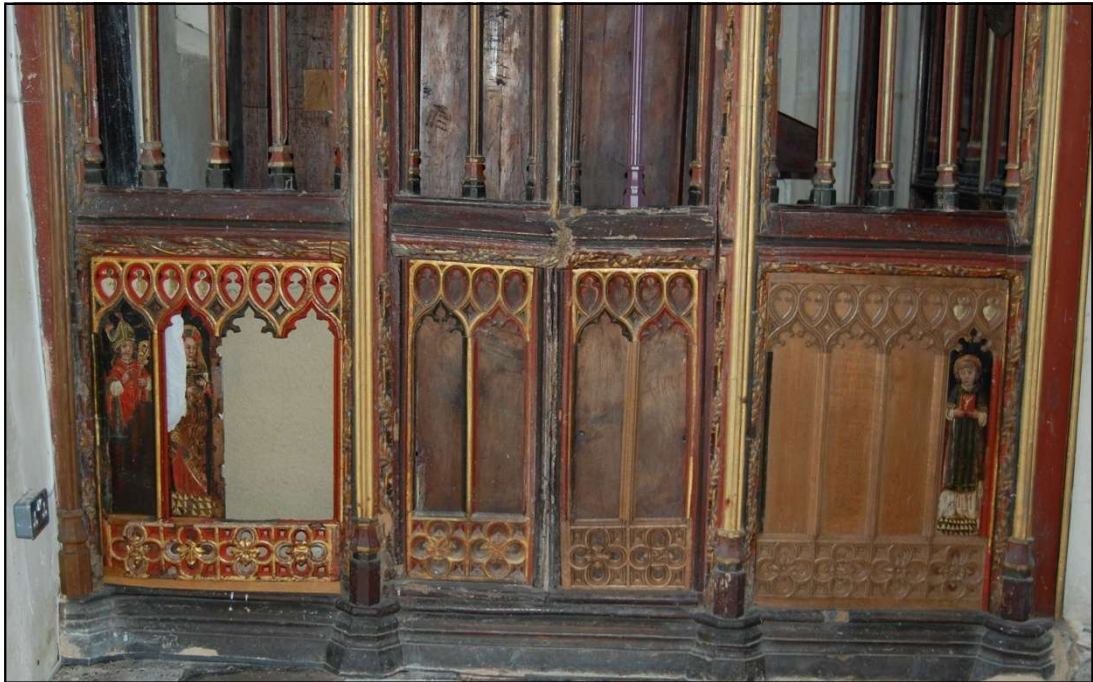
Above, north aisle screen, showing Bay 1, with damaged female saint and two southernmost missing (stolen) panels. Three panels stolen from Bay 3 in 2003 were eventually replaced with carved blanks (see top right) made by carver Laurence Beckford working for Hugh Harrison.

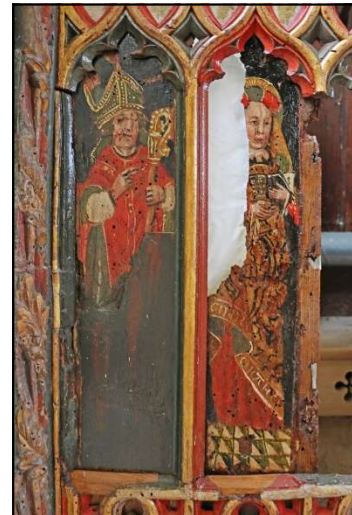
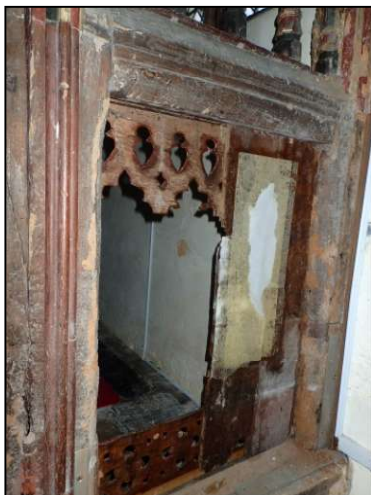
Above overview and right detail, after application of emergency facing paper by conservator Jane Rutherford and below details of smashed fragments stored in shoebox. The panel is clearly weakened by death-watch beetle tunnelling.

Bay 1, back view after theft. Showing facing paper supporting the female saint and spaces where the stolen panels would have been housed.

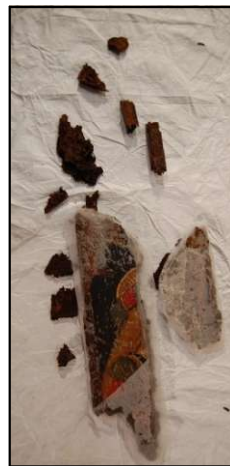
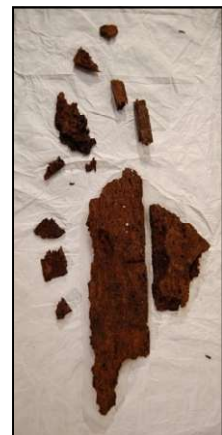
Fragments before re-assembling. Left, front face. Right, back view, showing how deteriorated the wood is.

This panel was deliberately smashed in order to steal the neighbouring two panels. Like all the panels this one is extremely fragile due to extensive tunnelling from death-watch beetle and the blows it will have received during the theft broke it into several pieces. The larger south section remained in situ, held in place by the architectural framework (see previous page) as well as facing paper (showing as white in the photographs).

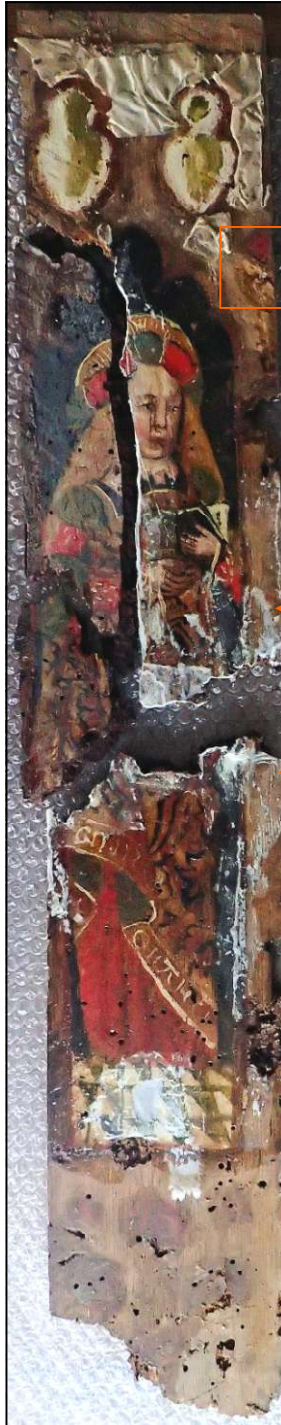
Detail showing powdery wood and beetle frass.

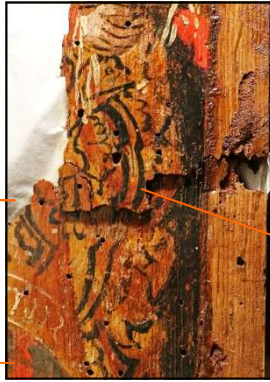
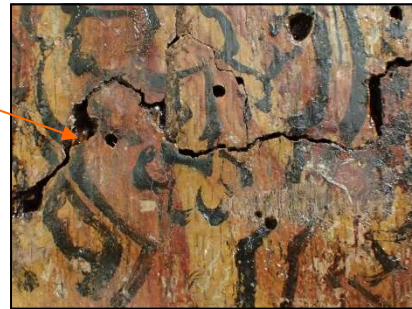
Above left, after removal of protective facing paper, before fragments were re-assembled and re-aligned. Above right, detail, after joinery repairs. In this photograph the gap is still to be filled (see overleaf).

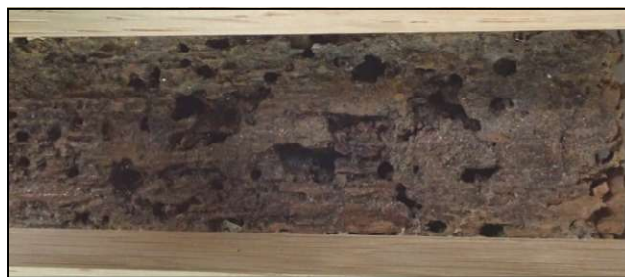
The back of the panel, as with all the panels, is severely degraded. Consolidant was applied in multiple applications over several weeks. The addition of inert fillers will have provided additional support to voids in the wood. However many weak passages could not be accessed. The tracery overlay and the specially designed architectural frame will provide the best protection for the panels once they have been re-installed in the church.

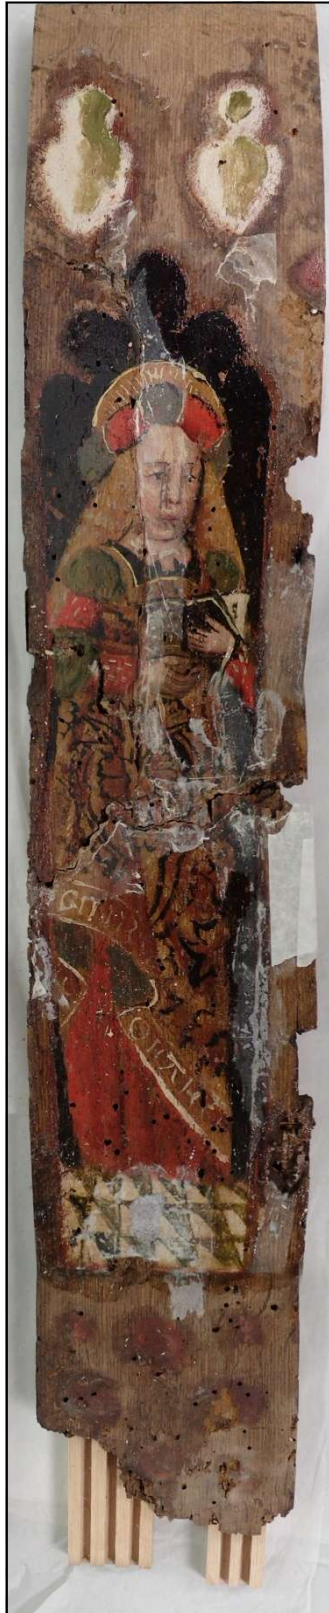
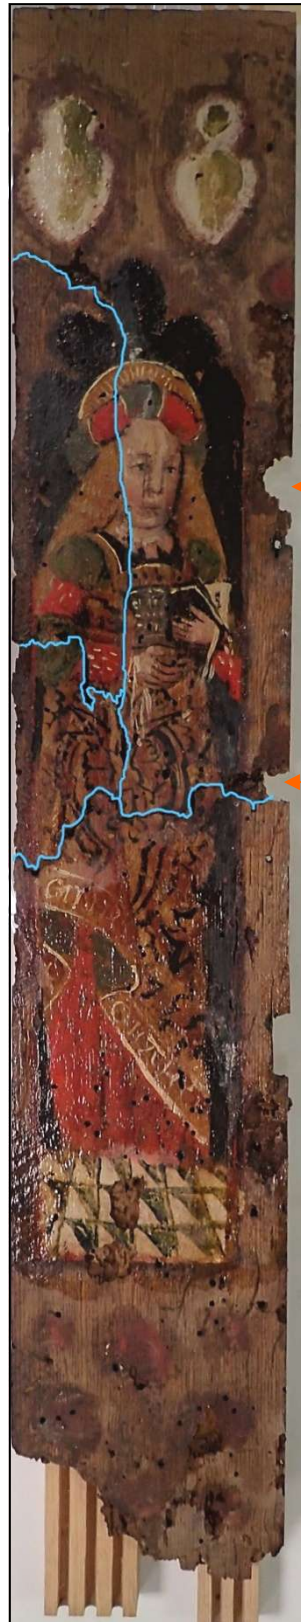
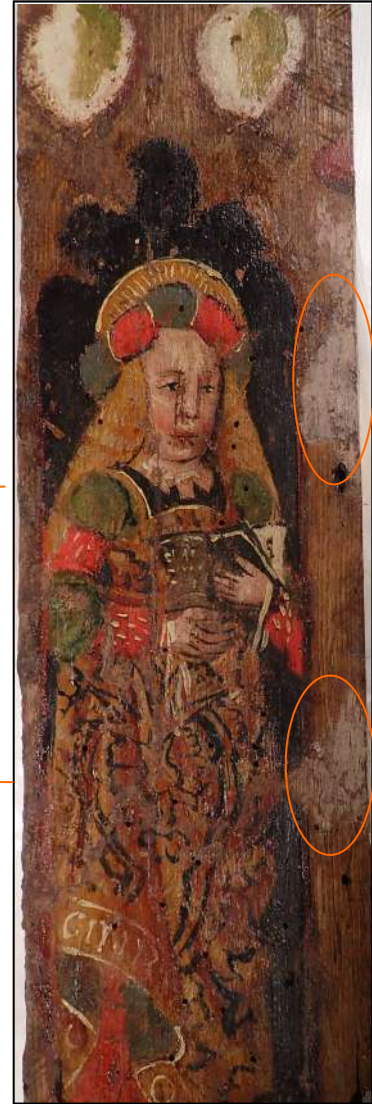
### Unidentified Female Saint

The broken fragments, once joined, needed fillings to bridge the gaps and restore integrity to the painting.

The edges of the panel were particularly deteriorated. Extensive deep fillings were necessary here to restore some strength to the edges (see red arrows, left image and red ovals above).

Fillings were built up in stages, before being cut back, and re-integrated over an isolation layer.

Panel after joinery repairs by Stuart Anderson, above left and above right with joinery repairs highlighted blue. Ribbed tulip wood battens, visible at the bottom of the panel, to be discussed in Hugh Harrison's report.

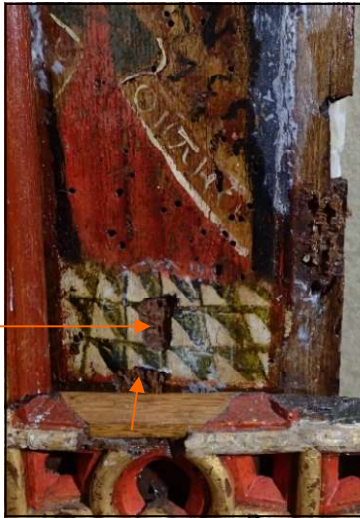
In situ detail. Area of decayed wood needing protection prior to dismantling. Note lower tracery overlay.

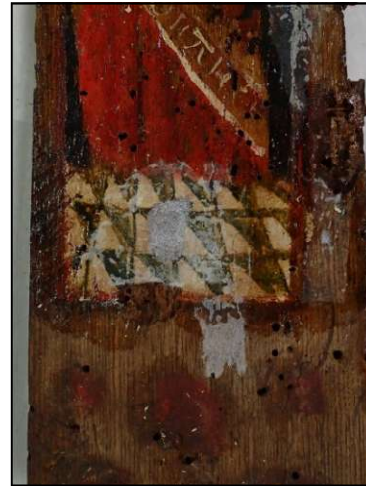
Damaged areas protected by facing paper (showing as a white veil).

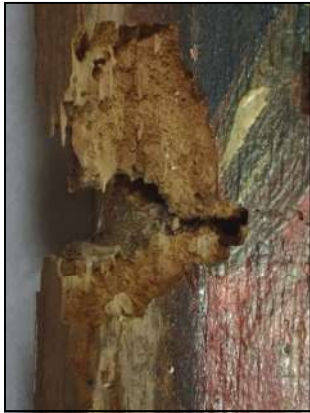
Above and below, details of the fragile edges. In places the surface was held together solely by the paint layers.

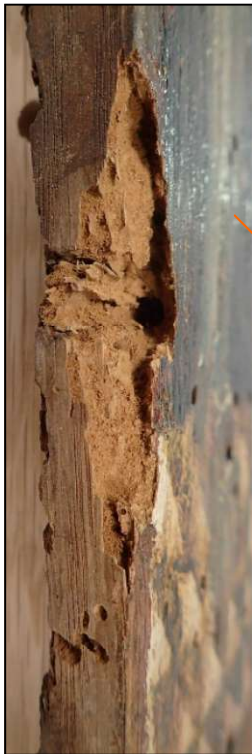
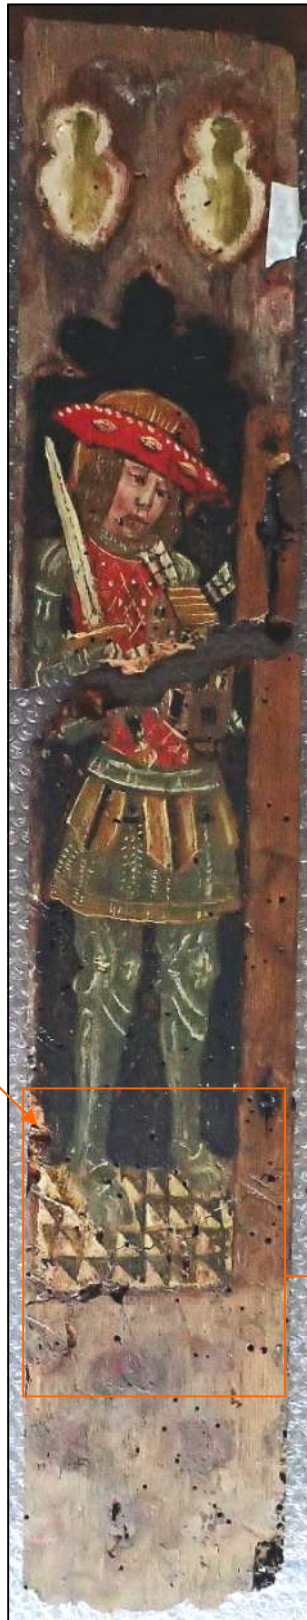
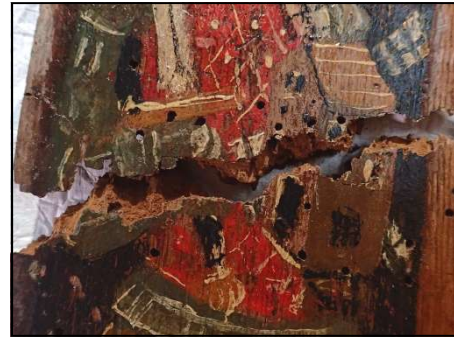
This panel had sustained two breaks.

Left and above detail show the main break across the panel and across the grain of the wood. The wood here was extremely soft and crumbling badly where death-watch beetle tunnelling had weakened it.

Below close-up showing break across the painted tiled floor, glued with a PVA type glue, by the 'thief'. Unlike on the St Margaret panel, the joint was relatively successful and more damage would have been caused to reverse it. It was therefore left and surface fillings bridged the space.

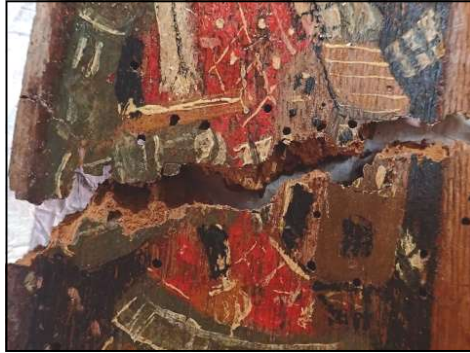
## St Victor of Marseilles

Close-up above, showing the break across St Victor. Conservation joiner Stuart Anderson glued the broken section and re-assembled the panel (right overview and blue highlight below).

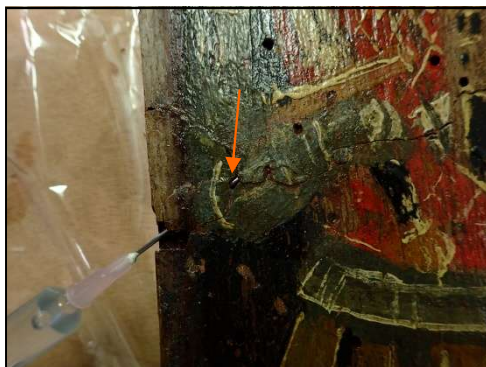
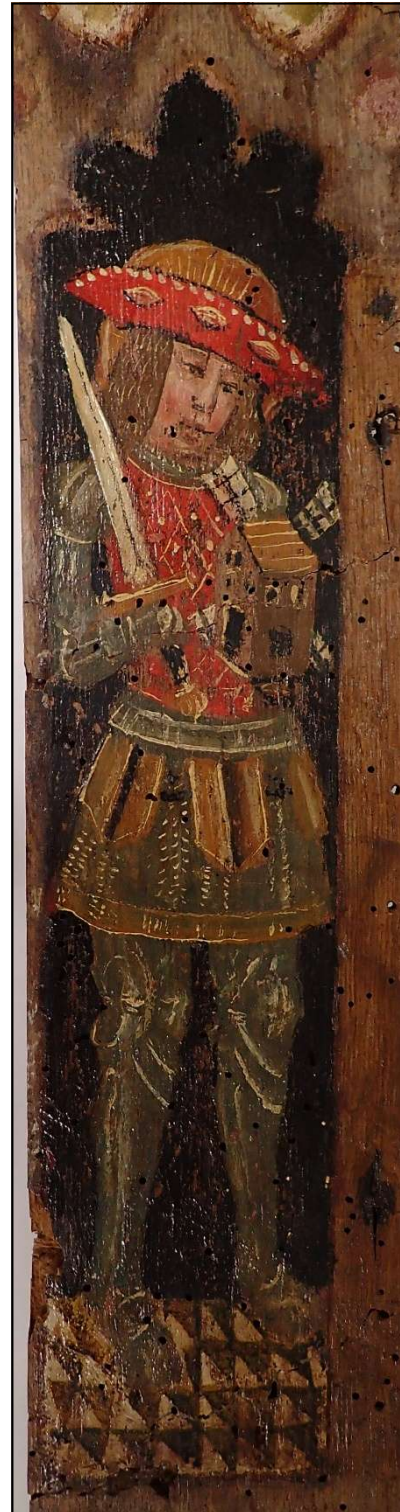
St Victor re-assembled. It was fortunate that there were smaller losses around the surface of the break than on the St Margaret panel, so a tighter joint could be achieved here.

However, within the body of the panel there were significant voids and a considerable amount of consolidation was required. Where accessible, voids were filled. This was not always possible.

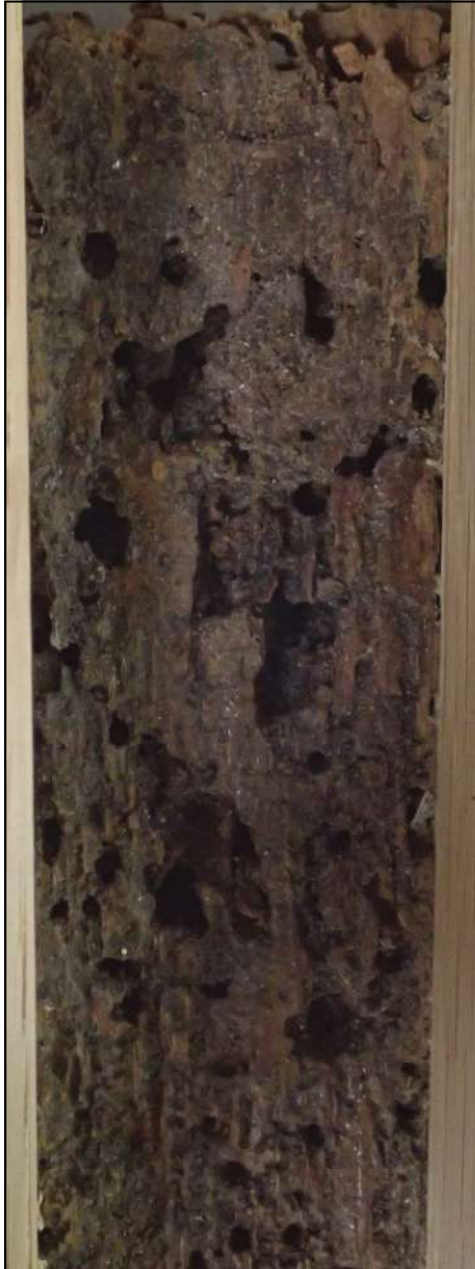
Detail showing condition of back of panel.

The timber has been badly damaged by damp and death-watch beetle.

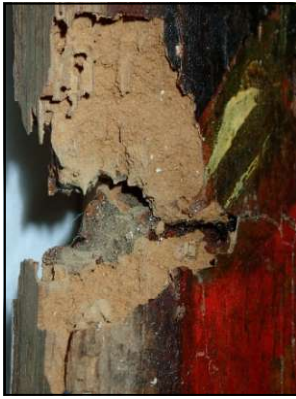
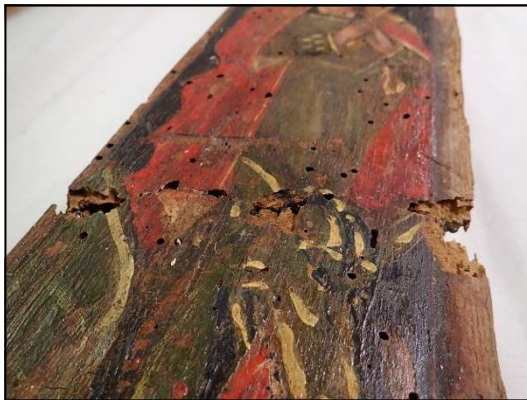
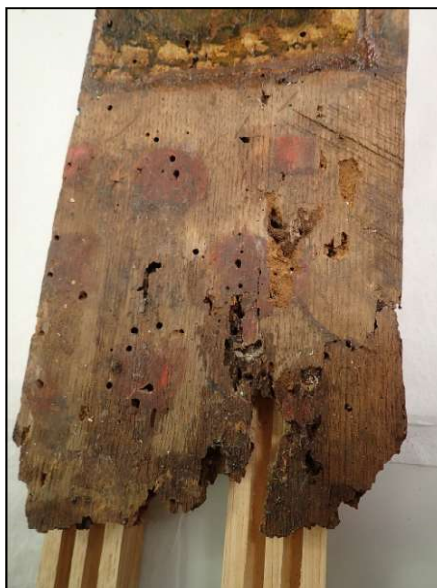
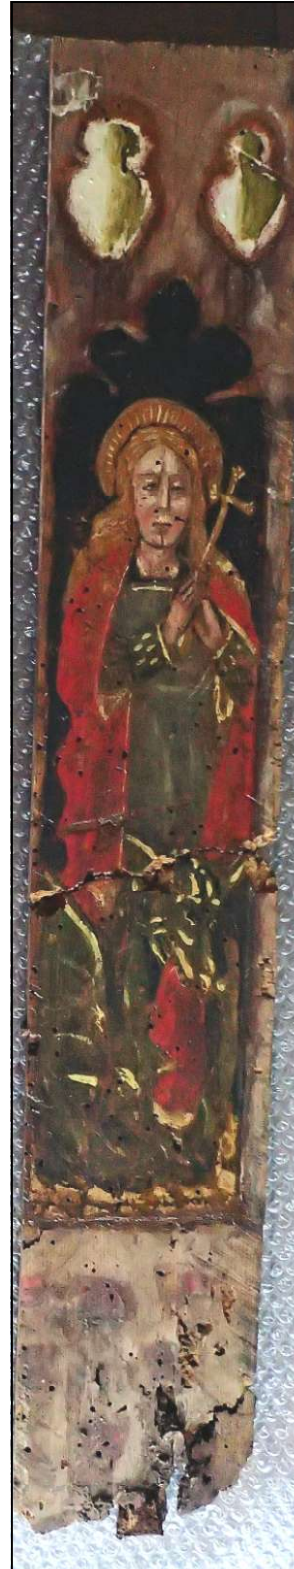
**St Margaret**

St Margaret, patron saint of women in childbirth, is depicted in medieval iconography as emerging from the belly of a dragon.

This panel was also split in two, sadly across the dragon. Here the crumbling wood was so severe that large portions of the surface of wood and paint were missing (see also overleaf).

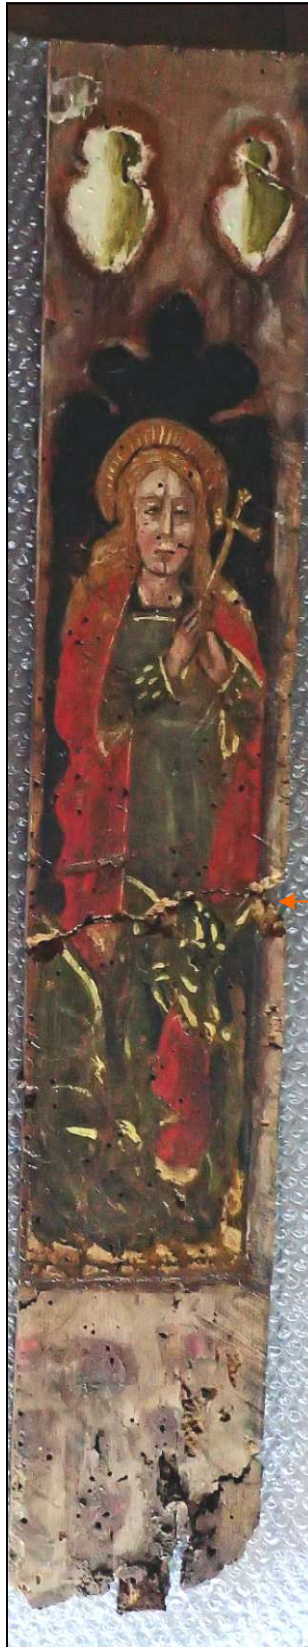
St Margaret before joinery repairs

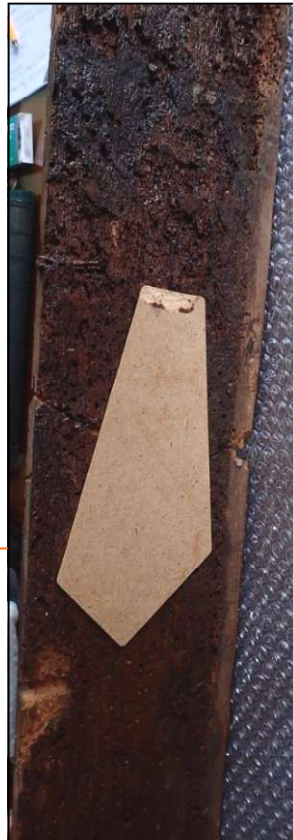
When the panels were retrieved, a crude support was visible on the back, across the break of St Margaret. As can be seen above, a splint made from a picture frame was attempting to 'hold' the two sections together .

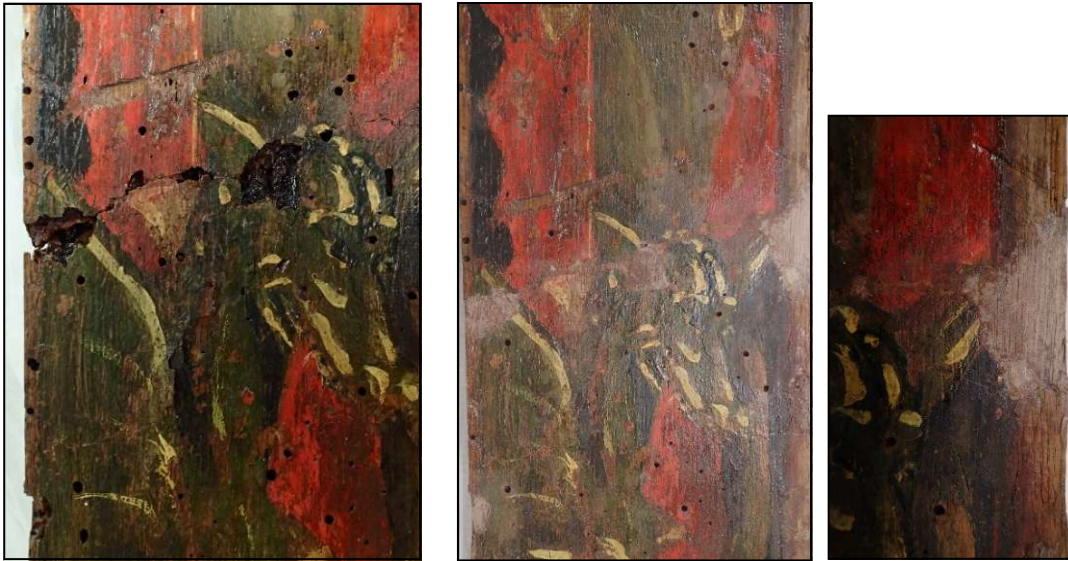
Above left, during consolidation of wood along the break. Note how much of the surface is missing here. Above centre, fillings have been built up and cut back. Detail of filling shown top right.

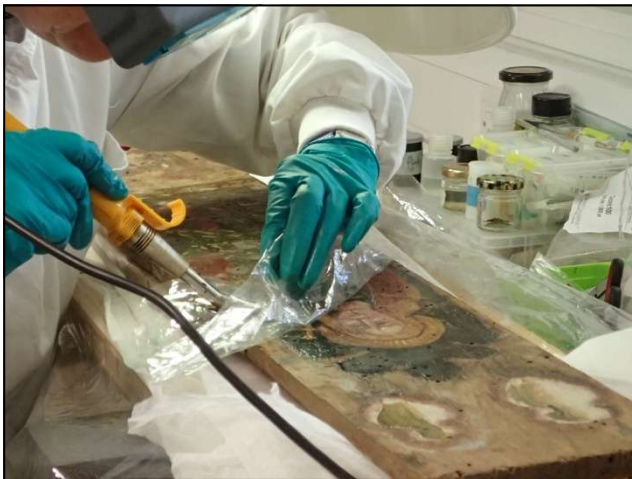
Using a heated spatula to lay back detaching paint, after application of consolidant.

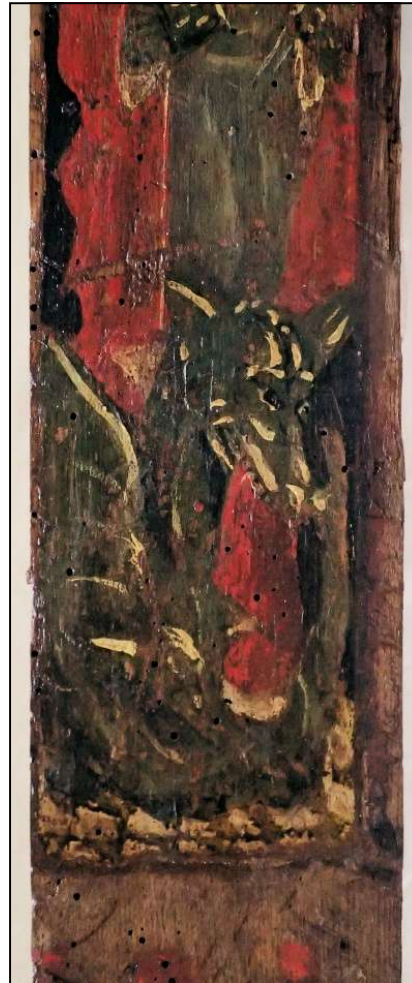
Lower part of panel showing dragon on completion of consolidation, fillings, reintegration of losses and varnishing.

Note the deep gash across the panel, just above the dragon. This is from previous iconoclasm and has been left, as it is stable and remains part of the history of this panel.

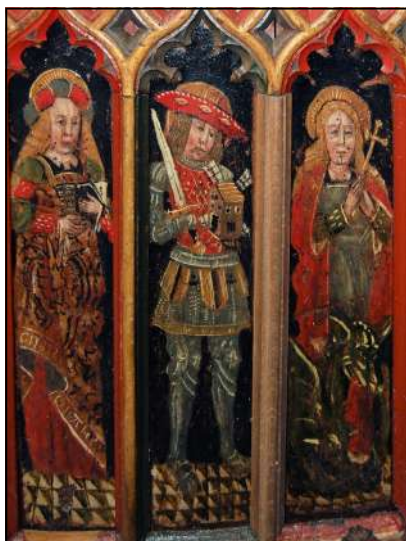
Above, detail of Bay 1 after conservation by Jane Rutherfoord, between 1999 and 2013.  
Above right Bay 1 after the theft in 2013 and vandalism of the adjacent panel with the unidentified female saint.

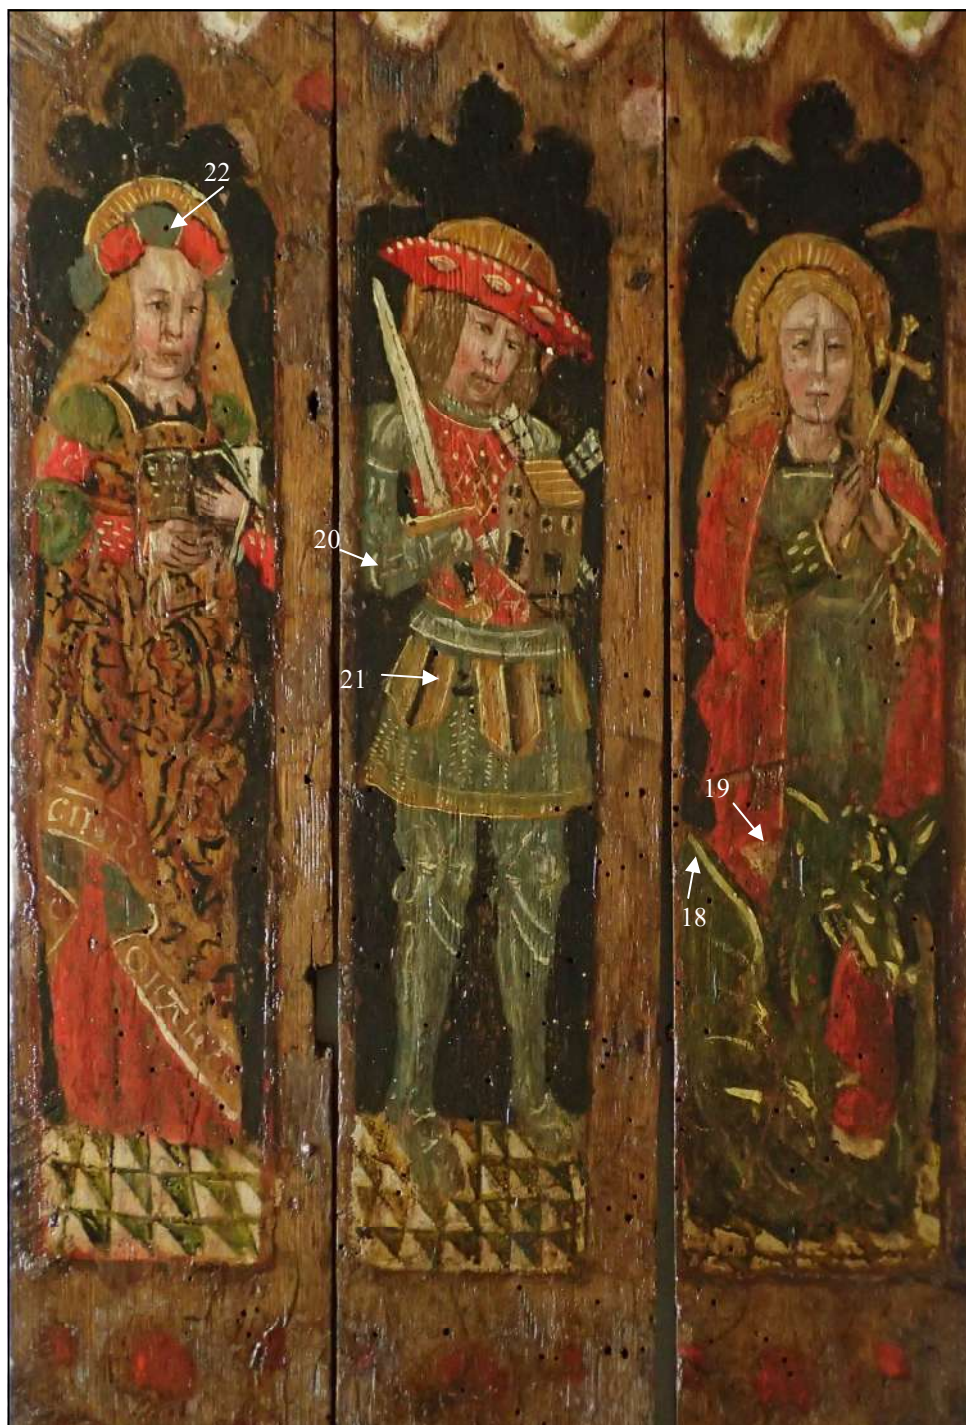
Location of paint samples (see arrows above). Numbering continuing from previous analysis in 1999.
