# Holy Trinity Church, Torbryan, Devon

## Rood Screen Panels

March 2016

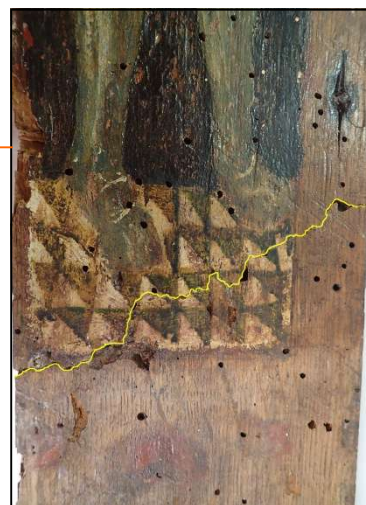
Left and above detail show the main break across the panel and across the grain of the wood. The wood here was extremely soft and crumbling badly where death-watch beetle tunnelling had weakened it.

Below close-up showing break across the painted tiled floor, glued with a PVA type glue, by the 'thief'. Unlike on the St Margaret panel, the joint was relatively successful and more damage would have been caused to reverse it. It was therefore left and surface fillings bridged the space.
